**02/02/2004**

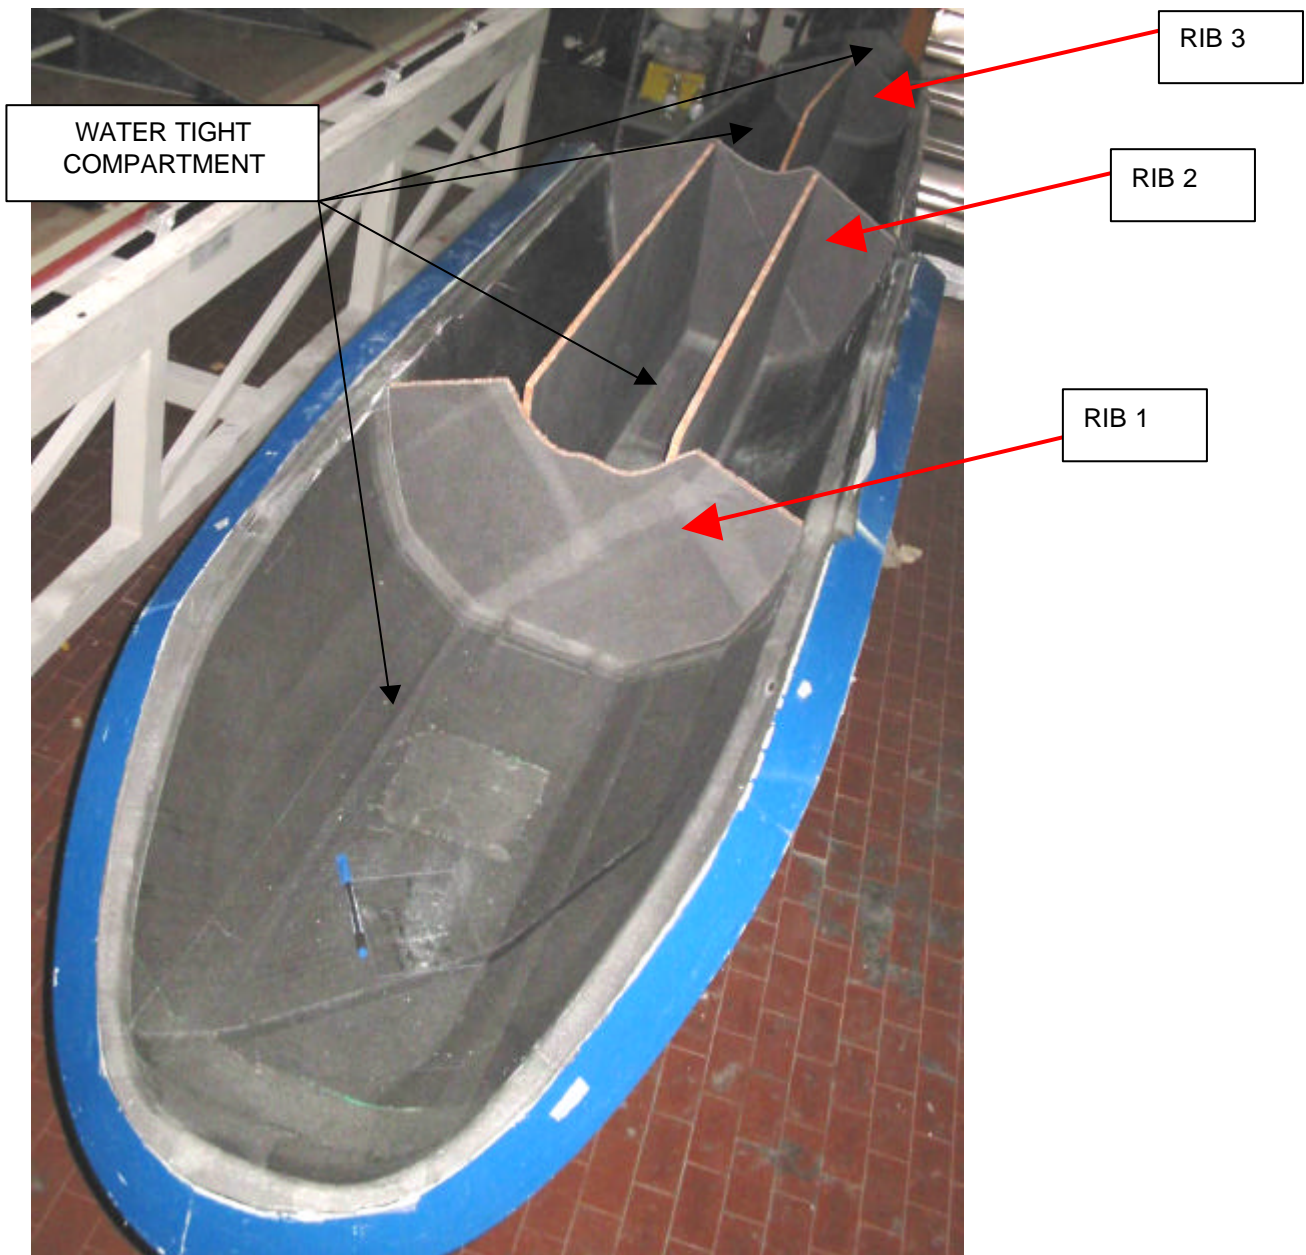
THE PICTURE BELOW SHOWS THE RIBS, AS INDICATED IN THE CAD DRAWING..  
 ALSO SHOWN ARE THE FOUR WATER TIGHT COMPARTMENTS; THE THREE VANES IN THE CENTRAL  
 COMPARTMENT ARE CONNECTED.  
 THE PICTURE SHOWS THE UPPER SURFACE INSIDE THE MOULD
